The CNGS Reflector

CNGS Reflector Leak Review Meeting with AB, TS and RP experts, held on 29 Nov 06

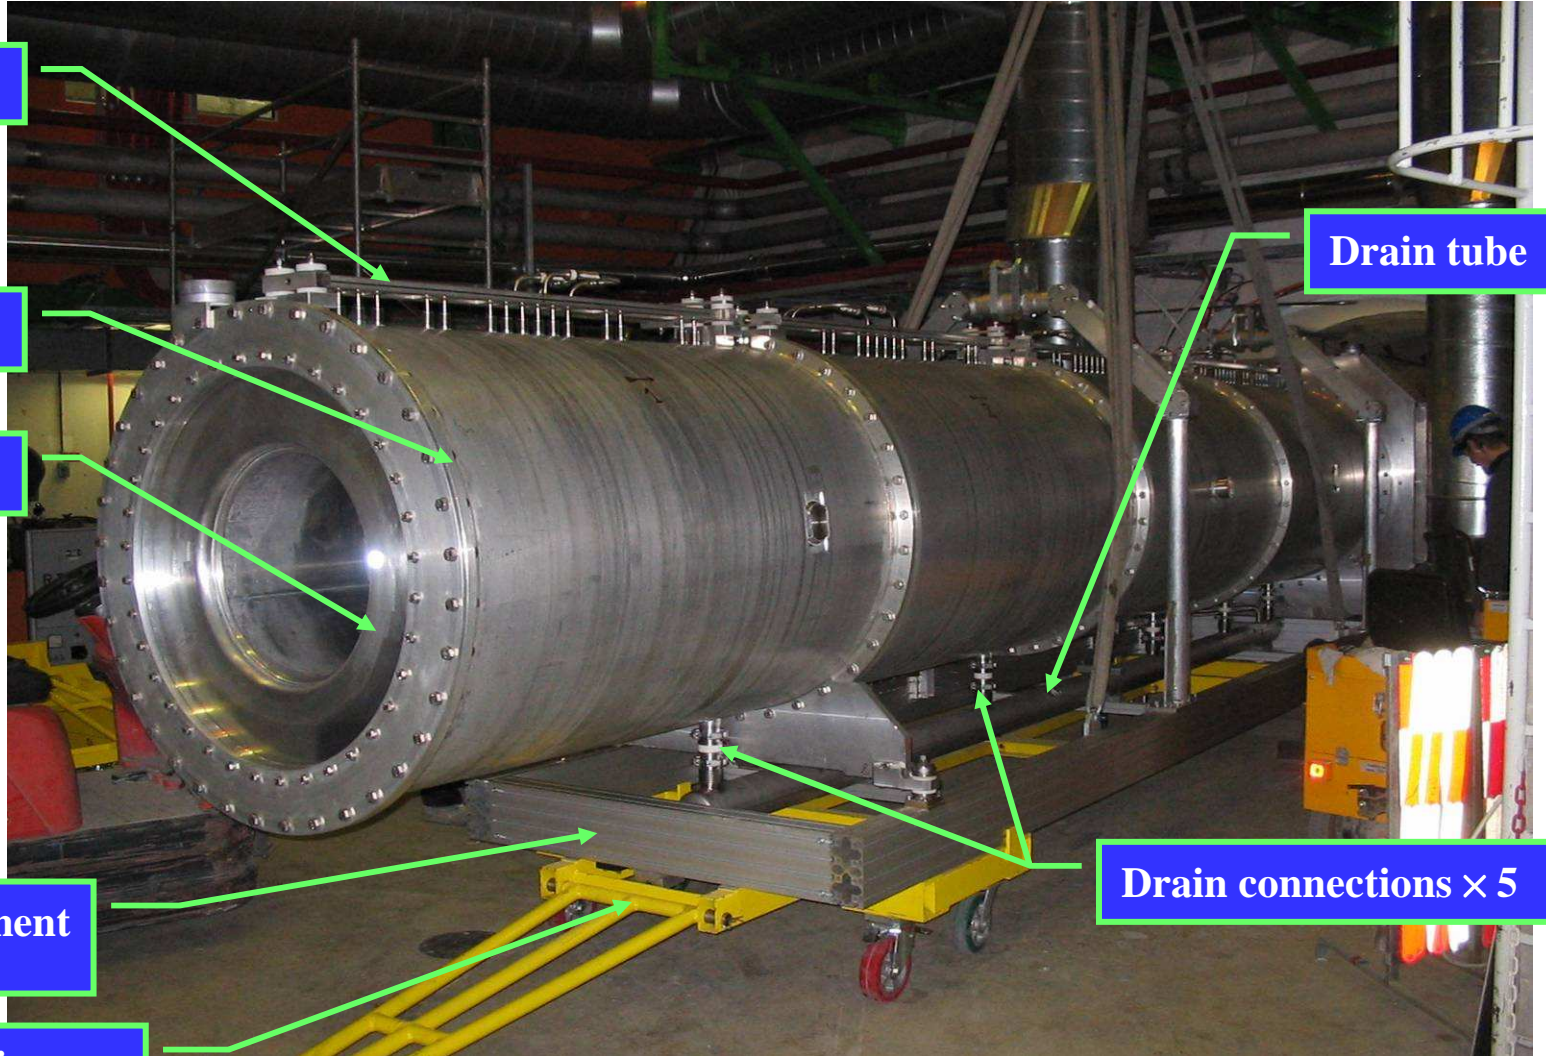
Water distribution

Outer conductor

Inner conductor

Drain tube

Support and alignment
frame

Transport chassis

Drain connections $\times 5$

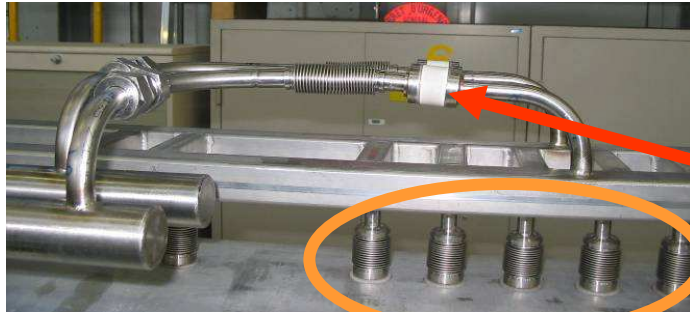
- **Water inlet bellows**

- Thin stainless steel foil brazed on ceramic sleeve
- Thin foil brazed to water tube

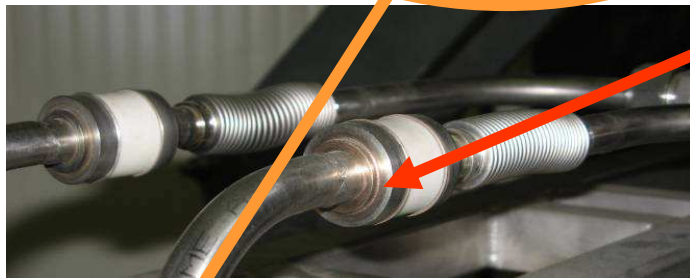
- **Water sprayers**

- Double-walled → no leak when bellows failure
- **50% already replaced**
